ARDCOAT SYSTEM SOLUTION

MANUAL FOR THE RESOLUTION
OF COAT SYSTEM PATHOLOGIES

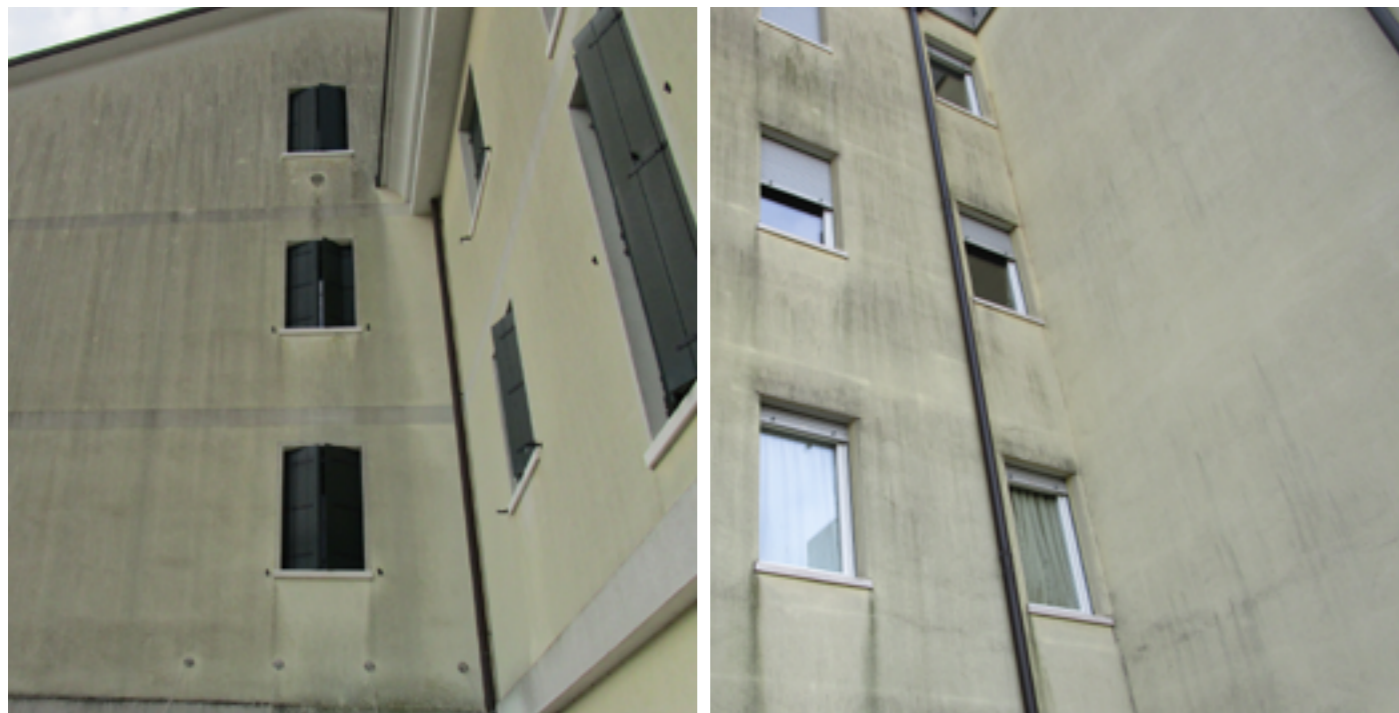
PRE-INTERVENTION SITUATION

Biological colonizations are algae, molds, mosses and lichens; these are unicellular and multicellular organisms that have different shapes, consistencies and morphologies. They are made up of stratiform proliferations and represent a typical phenomenon of the coat system, since by insulating the walls, the system prevents heat dispersion; consequently, the external surfaces of the coat are cold, thus favoring the condensation of the humidity present in the air (dew point) that wets the outermost layer of the coat, creating the conditions for the proliferation of these organisms. They form an irregular, inconsistent deposit that is poorly anchored to the support, their presence affects the aesthetic appearance and compromises the protective characteristics of the paint product.

During the cold season, the coat insulation system has the objective of maintaining the heat inside the buildings, therefore the external surfaces are colder and subject to greater condensation than traditional masonry; therefore, remaining wet for a long time, they are the ideal environment for the proliferation of microorganisms.

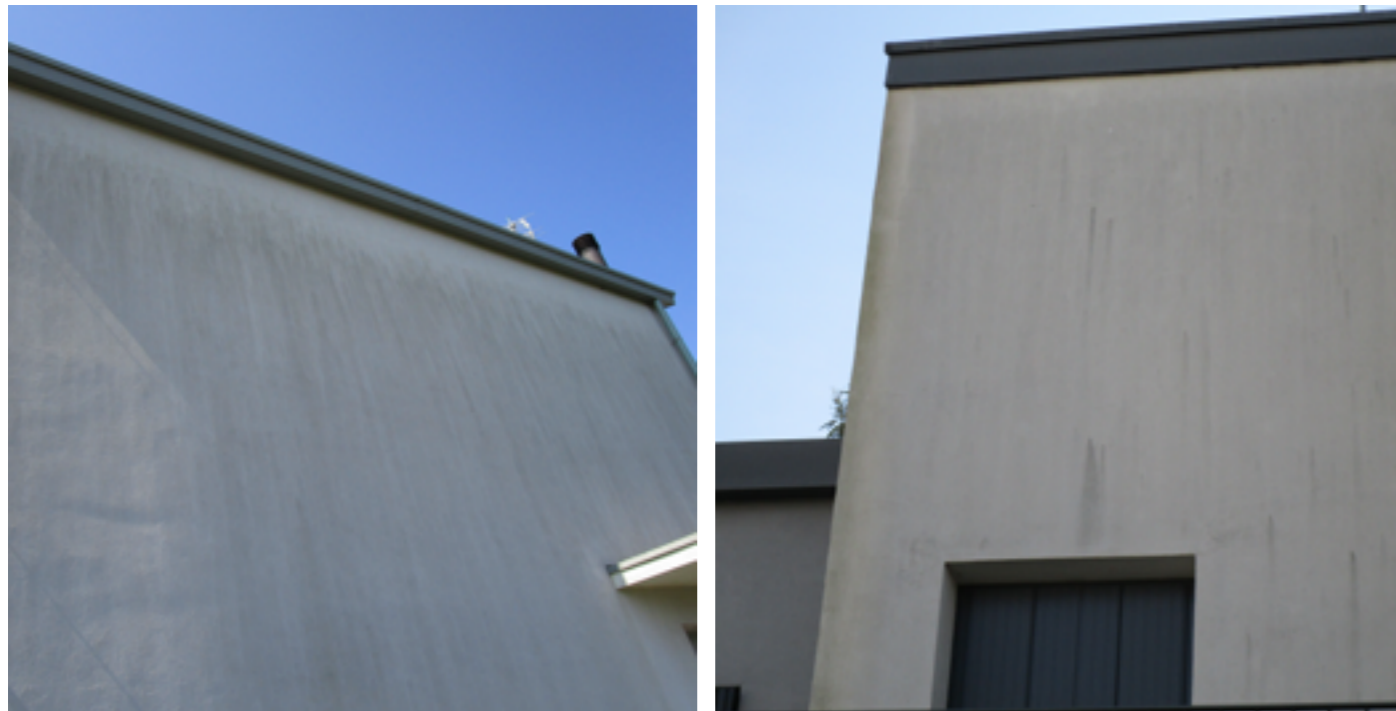
PRE-INTERVENTION SITUATION

Surface deposits are accumulations of foreign materials above the finish of the walls. They can be of various natures, organic or inorganic, and depending on the nature, their visibility, color, thickness, cohesion and adhesion to the substrate vary. They are due to atmospheric pollution (fine dust or particulate matter, PM10, PM2), and the proximity of industrial, artisanal, productive or agricultural areas that can spread dust, soil, soot, chemical deposits, precipitates and sand into the air. They affect the aesthetic appearance (graying or blackening of the affected surfaces) and can sometimes damage the substrate. Surface deposits are accumulations of foreign materials above the finish of the walls. They can be of various natures, organic or inorganic, and depending on the nature, their visibility, color, thickness, cohesion and adhesion to the substrate vary. They are caused by air pollution (fine dust or particulate matter, PM10, PM2), and the proximity of industrial, artisanal, productive or agricultural areas that can spread dust, soil, soot, chemical deposits, precipitates and sand into the air. They affect the aesthetic appearance (greying or blackening of the affected surfaces) and can sometimes damage the substrate.

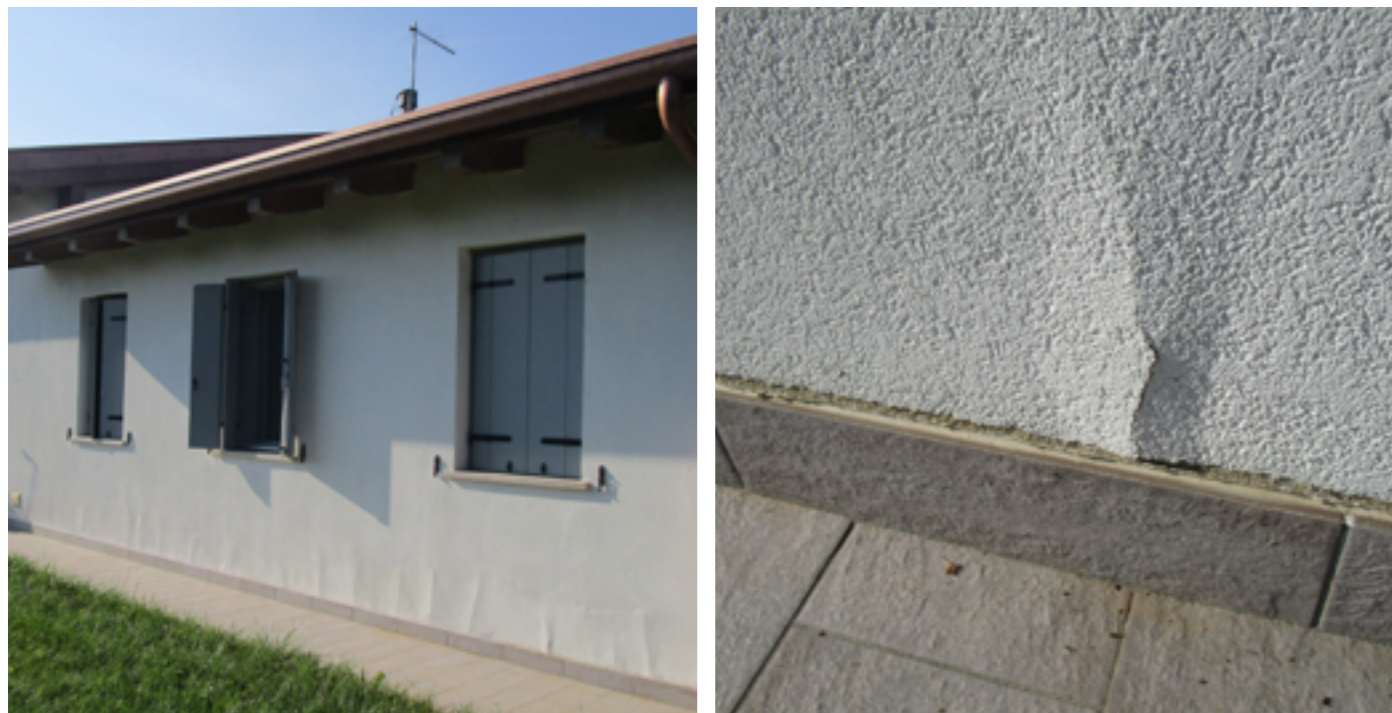
PRE-INTERVENTION SITUATION

The presence of humidity in the base appears in the form of wet and/or stained areas from the presence of water, subsequent salt outcrops and degradation of the surface layers. It is mainly caused by rainwater, the presence of rising damp by capillarity or by contact with stagnant water. The base area is subject to greater water absorption than the rest of the facades. It is important to take care of the design and installation of the first rows of insulation: the panels must be suitably applied above the walking surface (at least 2 cm), supported and correctly aligned by a starting profile.

Failure to take such precautions will result in water absorption and therefore humidity in the coat, compromising the performance of the thermal system and generating probable swelling and/or detachments of the final stratigraphy (skimming, base, finish).

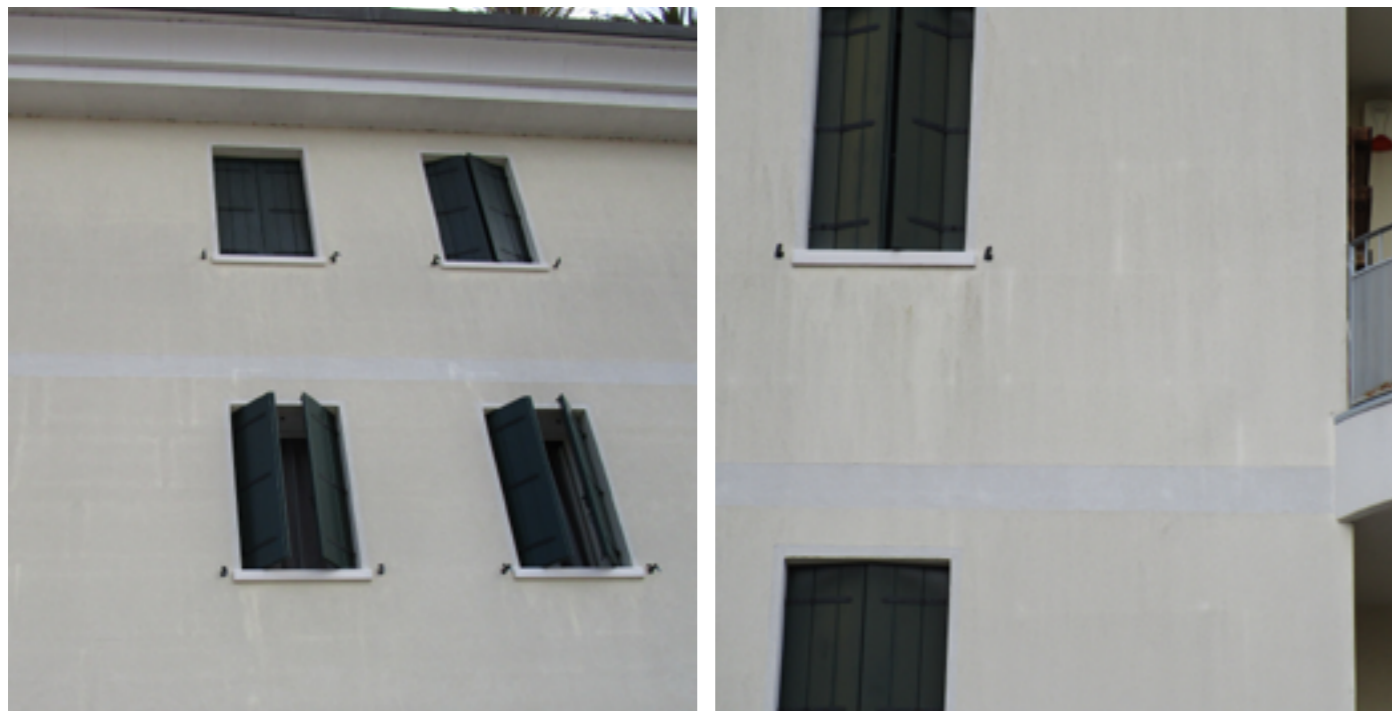
PRE-INTERVENTION SITUATION

Chromatic alterations are variations in the original color of the finish, they usually appear for three different causes: chemical aggression due to the degradation action carried out by the alkalinity of the support on some pigments due to lack of seasoning of the reinforced skim coat; chromatic heterogeneity due to different environmental stresses, application inexperience or performance differences between products of different compositions, applied at different times on the same facade; color change due to sunlight, specifically to the ultraviolet component (U.V.), which alters the chemistry of some types of pigment.

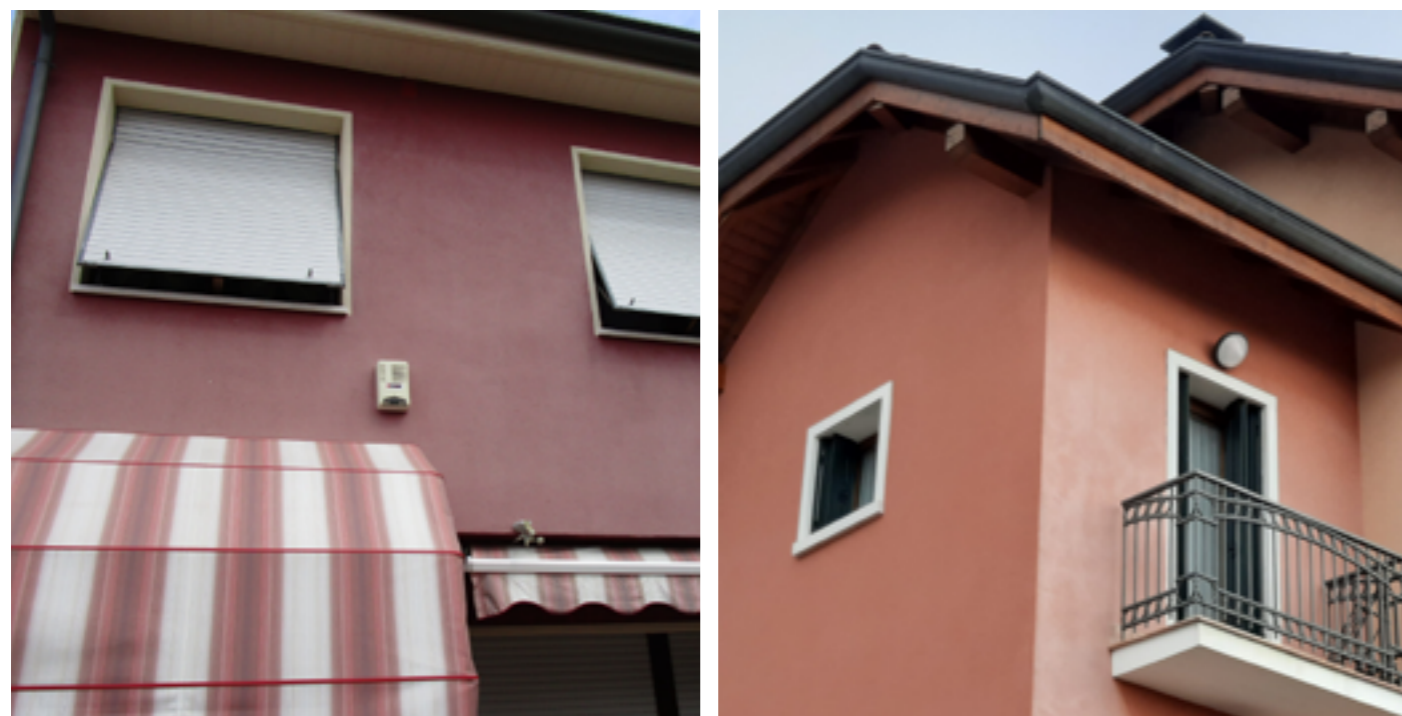
PRE-INTERVENTION SITUATION

Whitening of dark colors is that natural fading that occurs early compared to surfaces finished with other colors, due to overheating of the walls due to solar radiation.

Where exposure to the sun is more direct and prolonged, therefore on walls facing south, east and west, this phenomenon is stronger, on walls facing north, problems of this type do not occur. The overheating of the walls can generate significant thermal expansions in the various components of the system, causing further damage.

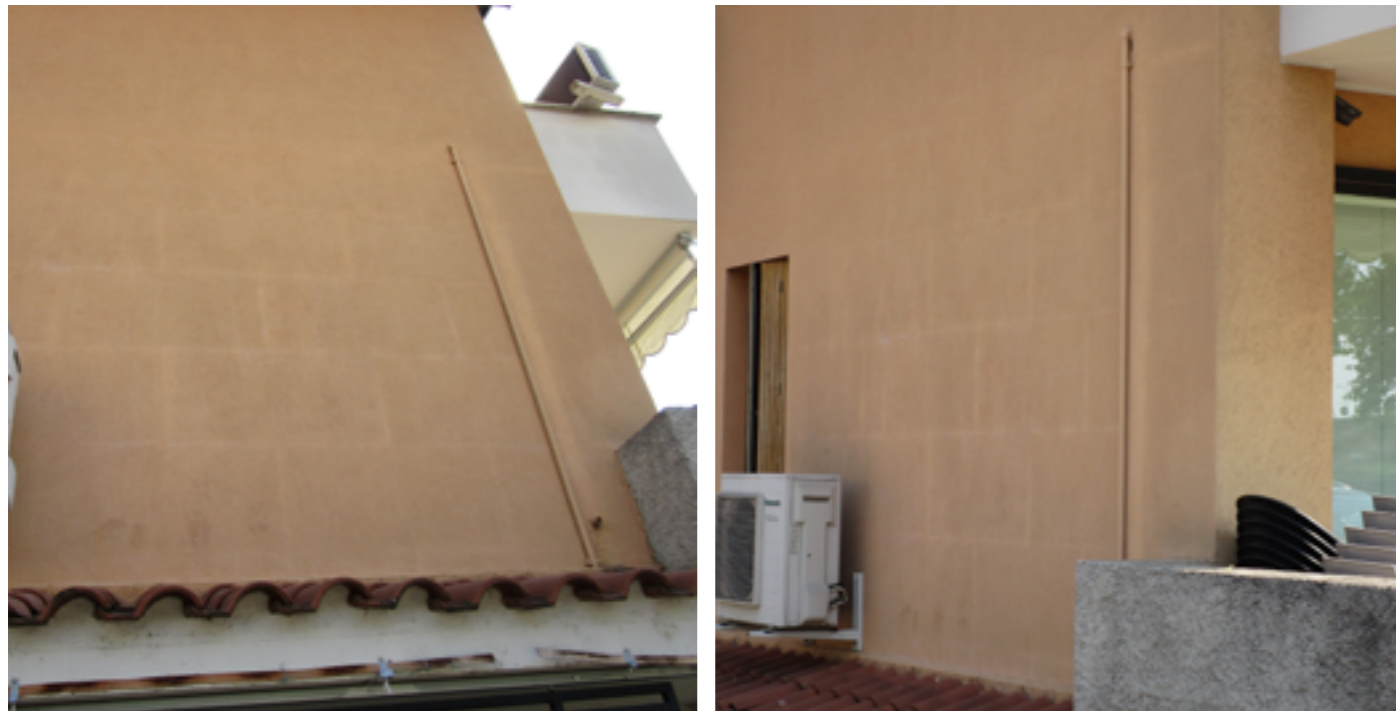
PRE-INTERVENTION SITUATION

Thermal bridges are discontinuities in the thermal conductivity of the building, they favor the dispersion of heat and cause degenerative phenomena of the support or aesthetic defects. They manifest themselves with the formation of clearings concentrated in specific areas, often having geometric shapes and defined perimeters.

They are caused by the reduction in thickness or the absence of insulating panels in correspondence of specific points, not adequately insulated, such as roller shutter boxes, windowsills, incorporations of protrusions, floors, string courses, jambs, pipes, etc. They can be identified using a thermal imaging camera or are visible to the naked eye.

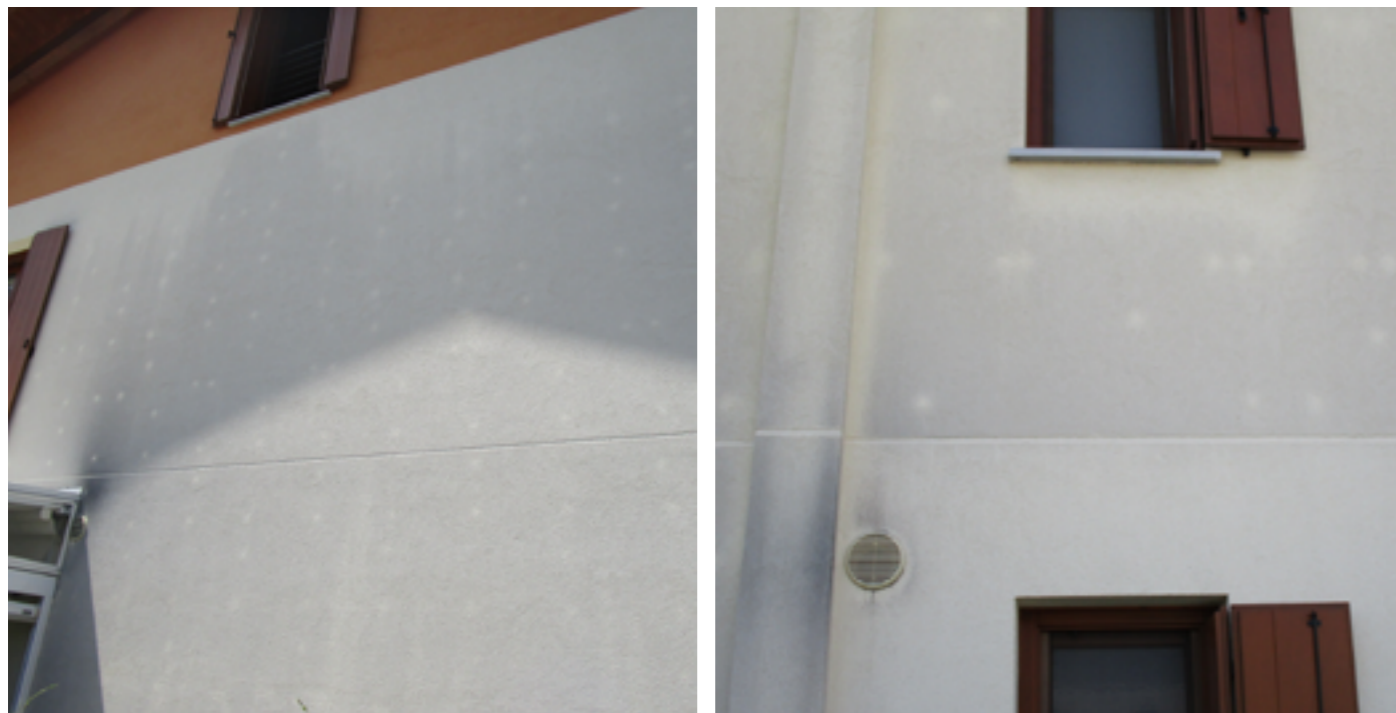
PRE-INTERVENTION SITUATION

Leopard-dowel spots are circular spots with a diameter of about 6/8 cm, lighter or darker than the finish color of the coat, located in correspondence with the fixing dowels.

They form when dowels with an insulating cap are not used, as dowels without a cap are heat conductors and therefore generate small thermal bridges.

When the humidity in the air condenses on the cold surface of the coat, wetting it (dew point), the stains become evident on the walls facing north. The heads of the dowels overheat more than the plaster, melting the frost first or causing the corresponding surface to dry first and generating the stain. On surfaces facing south, the phenomenon can occur in the opposite way. The surface of the insulating panel heats up, not allowing heat to enter and the color degrades more quickly than the color in correspondence with the dowels, which maintain a darker color than the rest of the facade.

This phenomenon is accentuated if the heads of the dowels are not coplanar with the panel (inserted too much or too little), and if the thickness of the reinforced plaster including the finish is less than 4.5 mm.

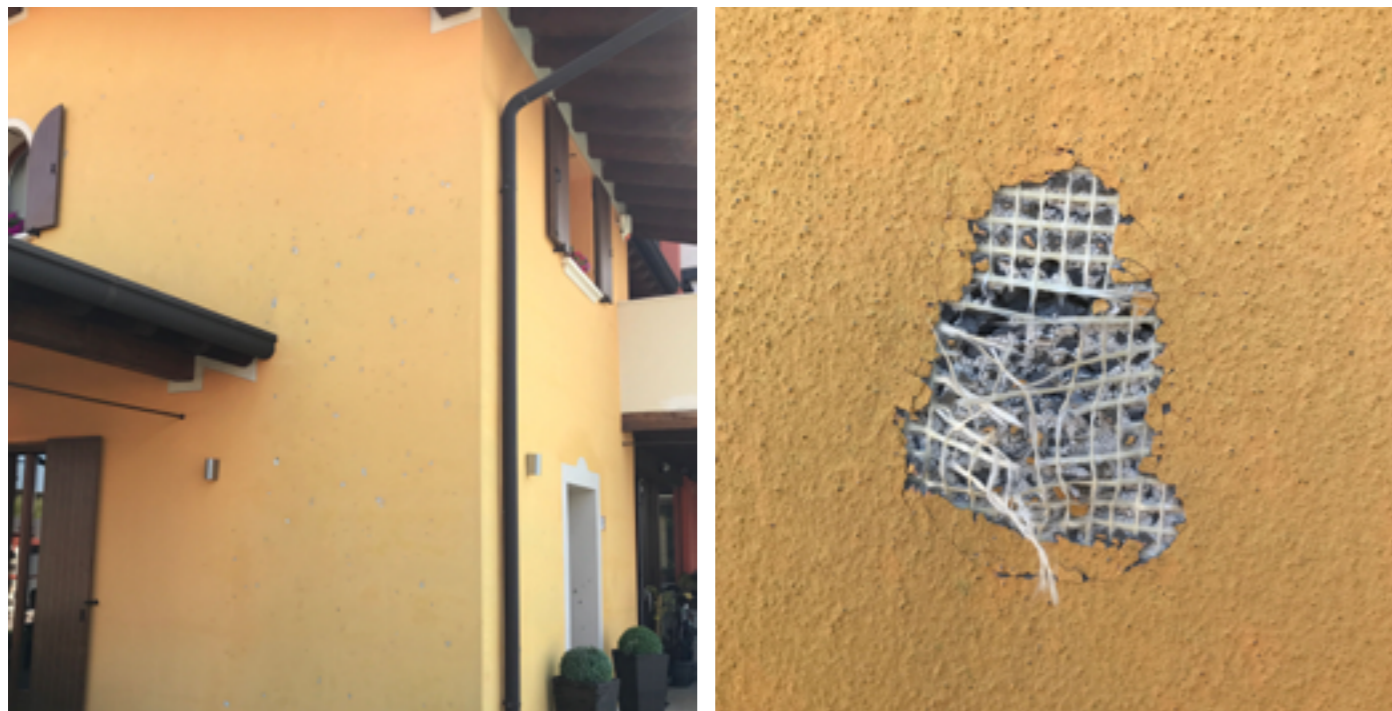
PRE-INTERVENTION SITUATION

Mechanical breakages and dents are all those damages that compromise the integrity of the layers protecting the insulating panel.

They are caused by accidental events such as impacts (external bodies) or by atmospheric agents (hail) that compromise the aesthetic appearance and reduce the thermal insulation capacity of the coat.

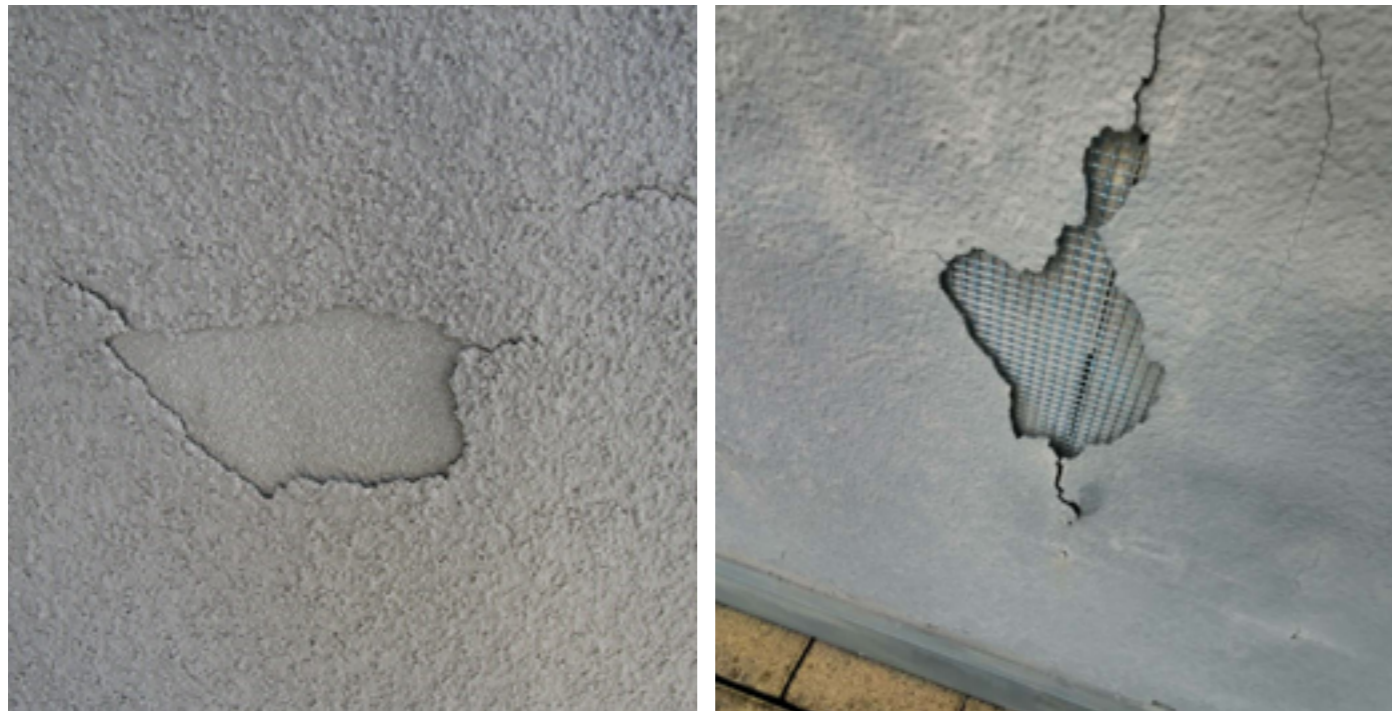
PRE-INTERVENTION SITUATION

Partial detachments of finishing (coating or paint) and reinforced skim coat are characterized by falling and loss of parts that occur due to the lack of adhesion between the layers involved. They are localized in specific points and can be caused by problems during the application phase (dirty surface, gaps in the base, non-homogeneous mix, non-uniform spreading, incorrect positioning of the reinforcement mesh, etc.), or by internal and external factors that occur subsequently (cracks, water infiltrations, presence of rising damp, salts, etc.).

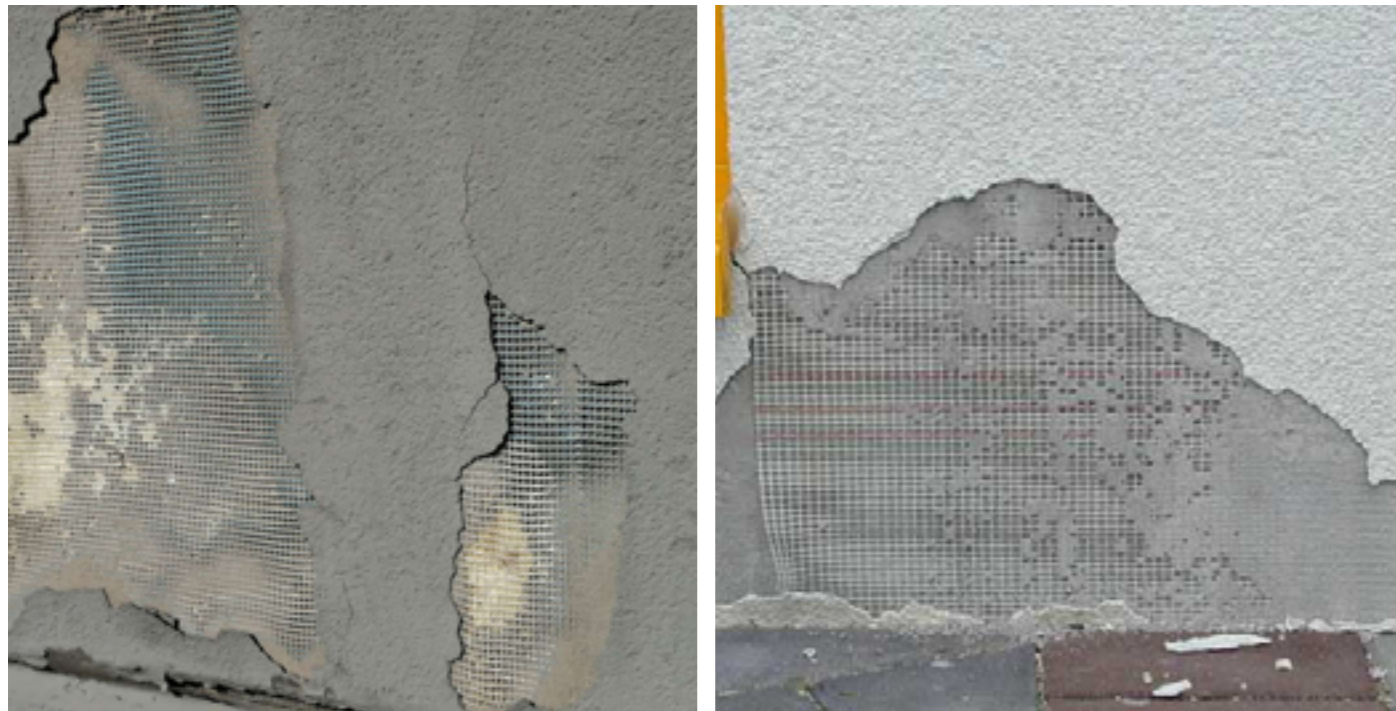
PRE-INTERVENTION SITUATION

Detachments of reinforced plaster over large areas are characterized by falling and loss of parts in large areas where the reinforced plaster has detached from the insulation. They can be visible if the underlying panels are visible, or appear as swellings that are barely perceptible visually, but audible as a dull noise amplified if the surface is struck. They are caused by problems attributable to the application phase (unsuitable plaster, unsuitable insulation, oxidized insulation, dirty insulation, dark overheated insulation, application in the sun, "burnt" plaster, insufficient thickness of the plaster layers, lack of anti-alkaline primer on the mesh, etc.).

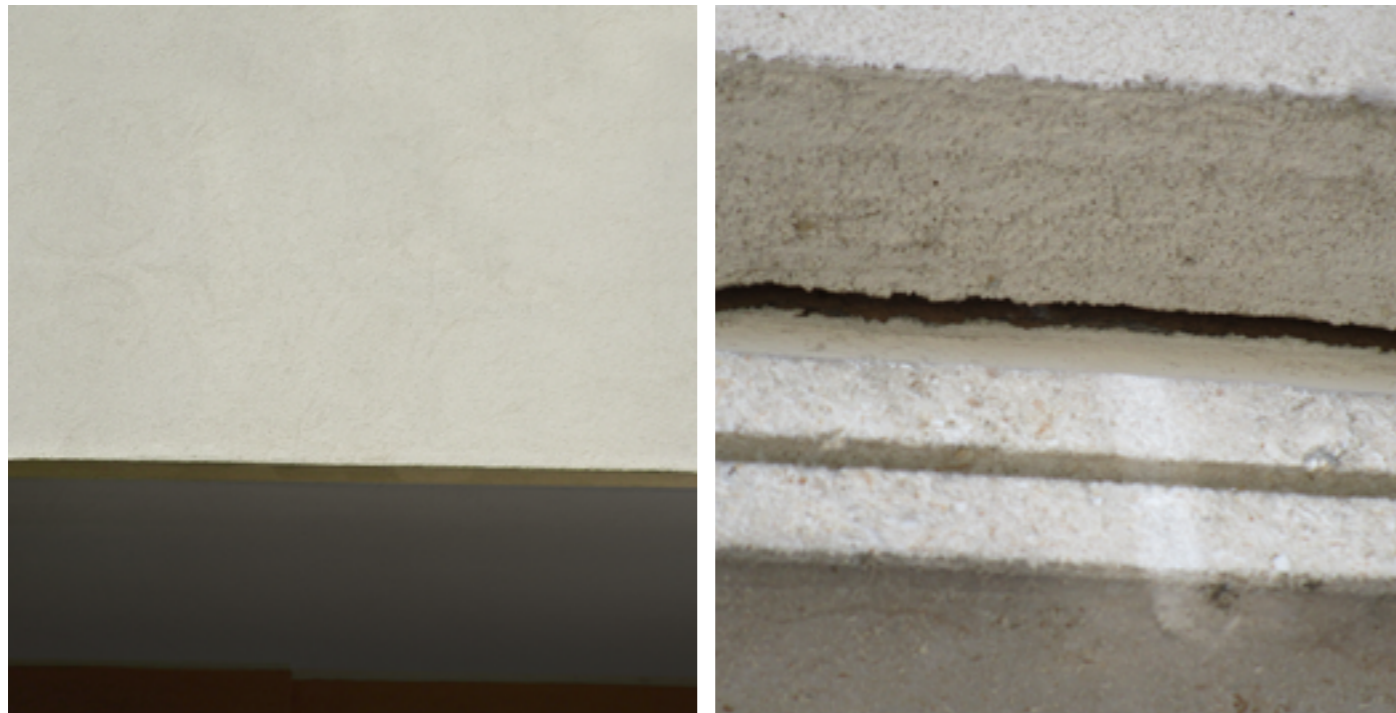
PRE-INTERVENTION SITUATION

The lack or incorrect installation of accessories can compromise the functionality of the system. The thermal insulation system, in fact, in addition to being composed of standard elements (panel, adhesive/skim coat, dowels, reinforcement mesh and finishing), is made up of a variety of accessories necessary for completing specific points (closures, guides, profiles, drip traps, self-expanding sealing tapes, expansion joints, fixing inserts, sheet metalwork, etc.).

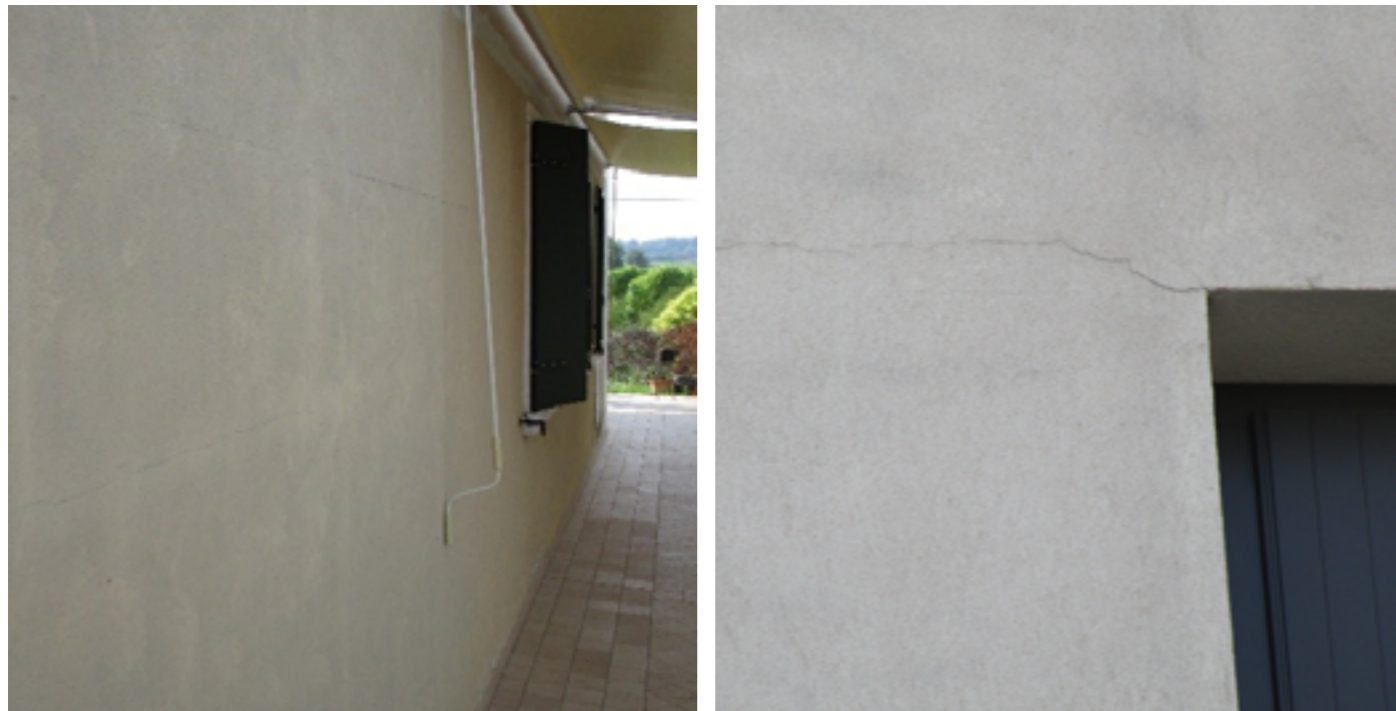
PRE-INTERVENTION SITUATION

Spiderweb cracks are hairline cracks in the finishing layers or the last layer of the reinforced plaster and appear with a reticular pattern.

They depend on the low mechanical resistance of the layer of material involved, which has poor solidity and a consequent loss of cohesion. They can appear shortly after application for various reasons (poor material, application errors, low thickness of plaster, exposure to atmospheric agents, etc.) and can also arise subsequently due to weakening of the material over time. This pathology occurs more frequently in external insulation systems completed with painting, in cases of inadequate stratigraphy.

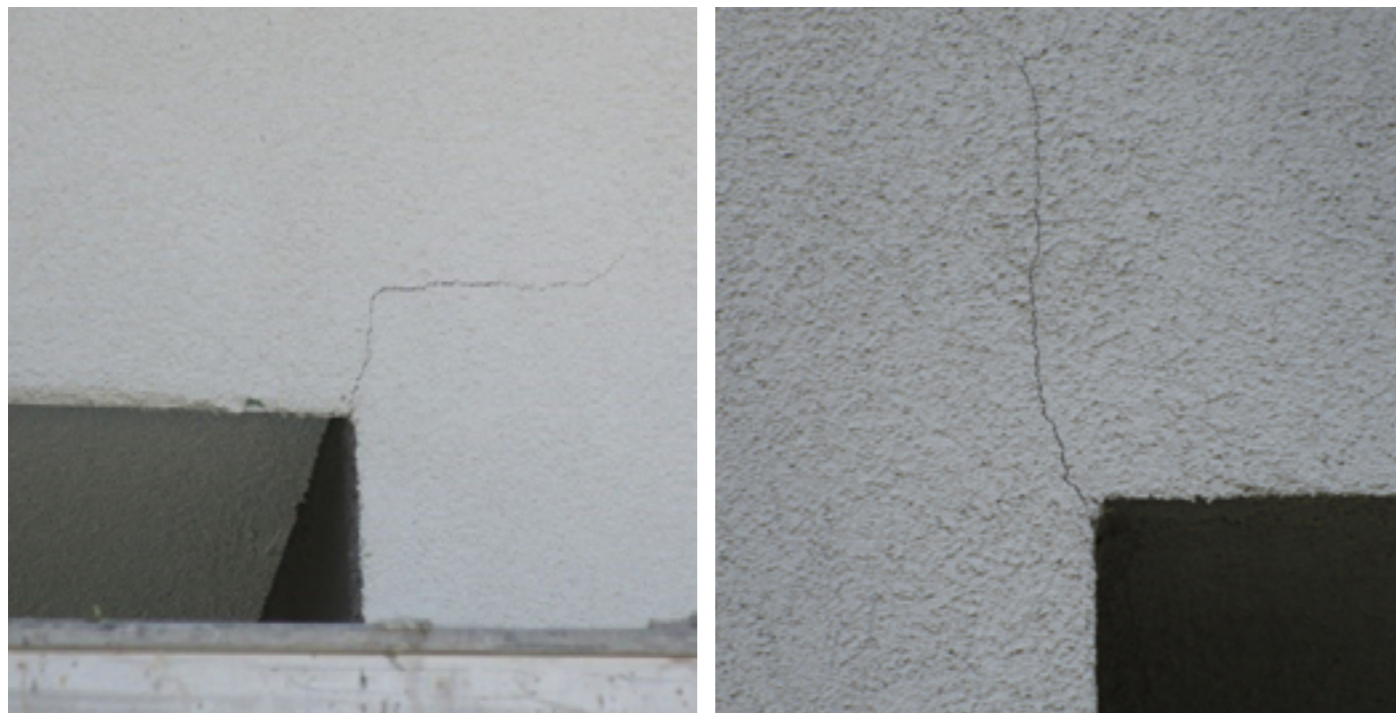
PRE-INTERVENTION SITUATION

Cracks at the corners of windows and doors are cracks or crazing - even thin ones - that originate at the corners of openings (windows, doors). They form linearly diagonally, vertically or horizontally and affect all layers of the reinforced plaster and finish.

They are called “structural” cracks because they are caused by tensions and stresses present in the structures of buildings or coats. They appear when the coat has been made without all the necessary precautions to counteract them (presence of joints between the panels in the corners instead of entire shaped panels, absence or incorrect installation of the 45° reinforcement mesh strips at these corners, insufficient thickness of plaster).

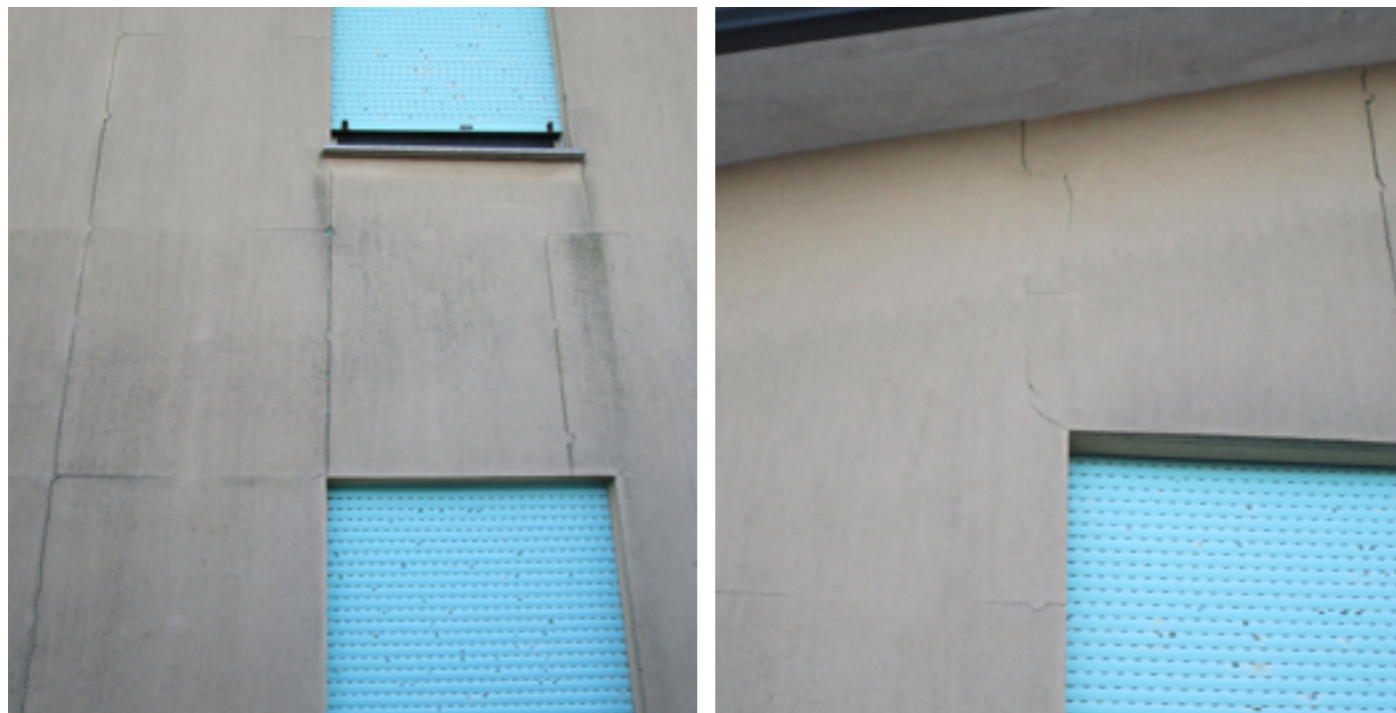
PRE-INTERVENTION SITUATION

Cracks in the joints between panels are horizontal or vertical cracks at the adjacent of the insulating panels. They are caused by technical application errors, such as failure to stagger the insulating panels, insufficient thickness in the smoothing layers, use of unsuitable reinforcement mesh, poor bonding surface of the panels, insufficient number of dowels, instability of the insulating panels, adjacency or insufficient overlapping of the reinforcement mesh, creation of dark-colored finishes.

In addition to compromising the aesthetic appearance, these cracks favor water infiltration which accelerates degradation and compromises the durability and optimal functionality of the thermal insulation system.

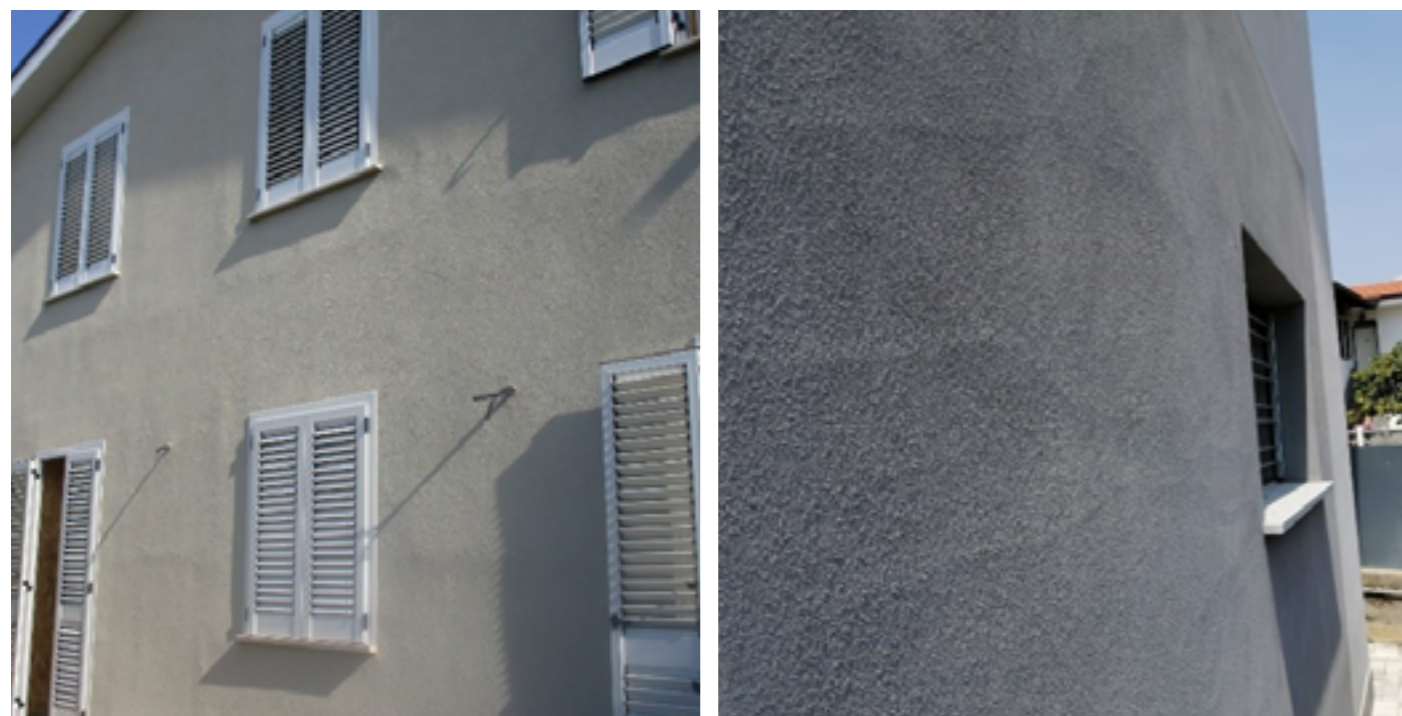
PRE-INTERVENTION SITUATION

The wavy surface is a deformation of the planarity of the facades due to the arching of the insulating panels outwards (cushion effect) or inwards (mattress effect).

It is also of fundamental importance, after gluing the panels, to anchor them mechanically with doweling using suitable materials and systems. These deformations are unsightly and compromise the efficiency of the thermal insulation.
